# Access Compliance Report Public Rights-of-Way (Curb Ramps)

Main Street: BALL\_RD Cross Street: PERDIDO\_ST Location: SE

ADA ID: RPRK210923172734 Ramp Type: Type 1 - Perpendicular Diagonal Initial Pass/Fail: Pass Overall Compliance: No Severity Score: 0

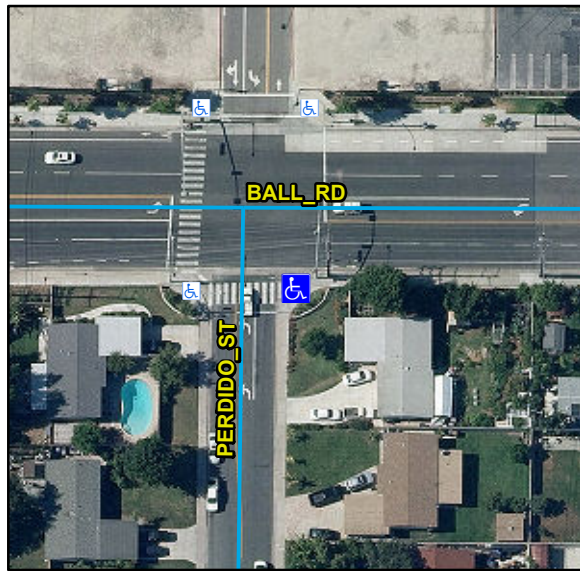
| Compliance | Description | Data | Compliance | Description | Data |
|---|---|---|---|---|---|
| Yes | Gutter Ponding | No | No | Curb Slope | 6 |

Remove & Replace Curb Slope.

R304.2.2, STD 1115
