# Access Compliance Report Public Rights-of-Way (Curb Ramps)

Main Street: PERDIDO\_ST Cross Street: BALL\_RD Location: SW

ADA ID: RPRK210923174136 Ramp Type: Type 1 - Perpendicular Diagonal Initial Pass/Fail: Pass Overall Compliance: No Severity Score: 8

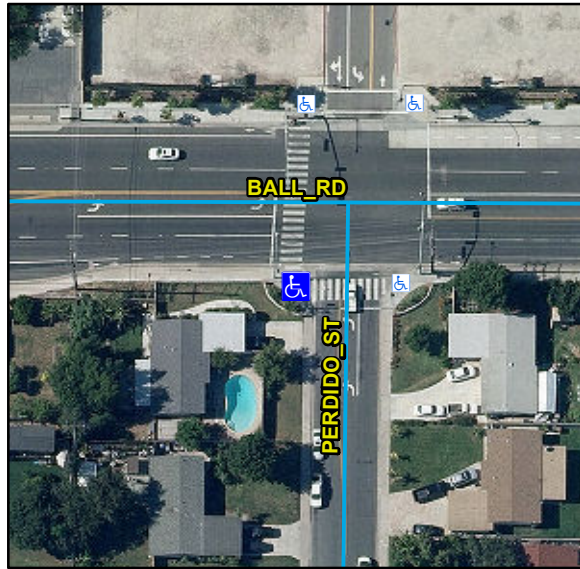
| Compliance | Description | Data | Compliance | Description | Data |
|---|---|---|---|---|---|
| Yes | Gutter Ponding | No | No | Curb Slope | 7.1 |

Remove & Replace Curb Ramp With Two New Directional Ramps or Equivalent.

R304.2.2, R304.2.1, STD 1115
