Access Compliance Report Public Rights-of-Way (Curb Ramps)

Main Street: BURGANDY PL **Cross Street: BIENVILLE AVE** Location: NE

ADA ID: RPRK210923180634 Ramp Type: Type 1 - Perpendicular Diagonalnitial Pass/Fail: Pass **Overall Compliance: Yes Severity Score:**

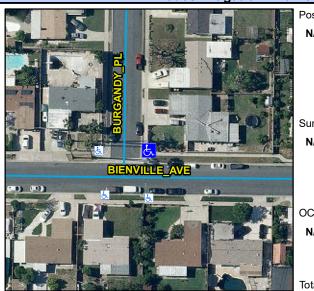
Field Measurements/Component Compliance									
	Compliance Description		Data	Compliance Description		Data			
	N/A	Ramp Length LT (in)	60	N/A	Ramp Length RT (in)	60			
	Yes	Ramp Width LT (in)	70	Yes	Ramp Width RT (in)	70			
	Yes	Ramp Run Slope LT (%)	4.6	Yes	Ramp Run Slope RT (%)	4.9			
	Yes	Ramp Cross Slope LT (%)	0.9	Yes	Ramp Cross Slope RT (%)	0.9			
	N/A	Landing Present	Yes	Yes	DWS Provided	Yes			
	N/A	Landing Length (in)	70	Yes	DWS Contrast	Yes			
	Yes	Landing Width (in)	48	Yes	DWS Length (in)	36			
	Yes	Landing Run Slope (%)	0.9	Yes	DWS Full Width	Yes			
	Yes	Landing Cross Slope (%)	0.9		DWS Offset Type	Single			
	N/A	Landing Movement Obstructed?	No	Yes	DWS Offset Left (in)	0			
		Landing Movement Type	Curb	Yes	DWS Offset Right (in)	N/A			
	N/A	Landing Shared	No						
	N/A	Clear Space	Yes						
	N/A	Clear Space To Crosswalk (in)	48						
0	N/A	Marked Crosswalk 1	No	N/A	Marked Crosswalk 2	No			
		Crossing 1 Direction	W		Crossing 2 Direction	s

L		Marked Crosswalk 1 Width (in)	N/A		Marked Crosswalk 2 Width (in)	N/A			
ı	N/A	Ramp Inside Crosswalk 1	N/A	N/A	Ramp Inside Crosswalk 2	N/A			
E		Crossing 1 Slope (%)	0.5		Crossing 2 Slope (%)	4.1			
ı		Crossing 1 Cross Slope (%)	0.4		Crossing 2 Cross Slope (%)	0.9			
	Yes	Gutter Ponding	No	Yes	Curb Slope	5.6			
	Yes	Gutter Lip Height (in)	0		Road Run Slope (%)	0.2			
	Yes	Gutter Run Slope (%)	4.9		Road Cross Slope (%)	2.1			
<u>a</u>	Yes	Gutter Cross Slope (%)	0.4	Yes	Perpendicular Joint Present	Yes			
0	Yes	S Overall Surface Condition Acceptable							
		Cross Gutter Present?	Yes		Spandrel Present?	Yes			
A		Replace Cross Gutter?	No		Replace Spandrel?	No

Possible Solutions: N/A
