# Access Compliance Report Public Rights-of-Way (Curb Ramps)

Main Street: BIENVILLE\_AVE Cross Street: MILNEBURG\_ST Location: SE

ADA ID: RPRK210923181920 Ramp Type: Type 1 - Perpendicular Diagonal Initial Pass/Fail: Pass Overall Compliance: No Severity Score: 12

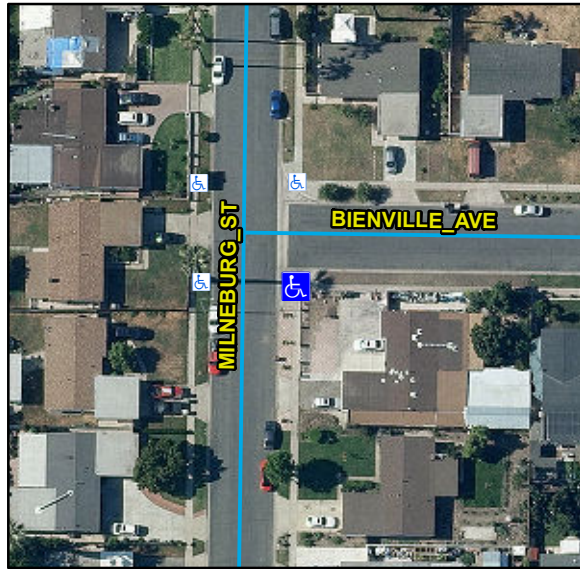
R204.3, R304.2.1, R304.2.2-Perp, R304.3.2-Para, R304.5.3, STD 1115

Remove & Replace Curb Ramp With Two New Directional Ramps or Equivalent.
