# Access Compliance Report Public Rights-of-Way (Curb Ramps)

Main Street: HEDLUND\_DR Cross Street: HARLE\_AVE Location: SW

ADA ID: RPRK210924111515 Ramp Type: Type 1 - Perpendicular Diagonal Initial Pass/Fail: Fail Overall Compliance: No Severity Score: 15

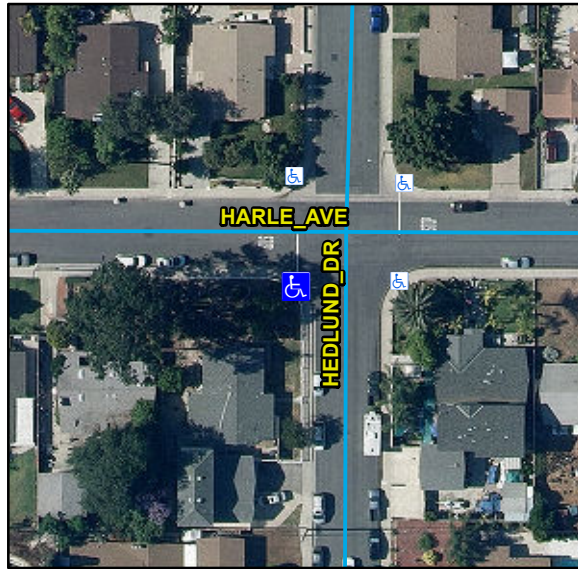
| Compliance | Description | Data | Compliance | Description | Data |
|---|---|---|---|---|---|
| No | Ramp Run Slope (%) | 11.4 | N/A | Flare Slope LT (%) | N/A |
| No | Gutter Lip Height (in) | 0.5 | | Road Run Slope (%) | 0.3 |

**Remove & Replace Curb Ramp With Two New Directional Ramps or Equivalent.**

**R304.2.2, R302.7.2, STD 1115**
