# Access Compliance Report Public Rights-of-Way (Curb Ramps)

Main Street: CERRITOS\_AVE Cross Street: HEDLUND\_DR Location: NW

ADA ID: RPRK210924113928 Ramp Type: Type 1 - Perpendicular Diagonal Initial Pass/Fail: Pass Overall Compliance: No Severity Score: 4

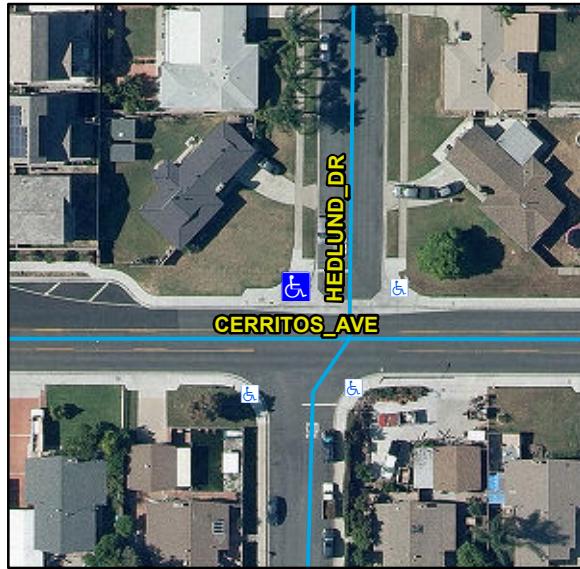
R304.2.2, R304.2.1, STD 1115

Remove & Replace Curb Ramp With Two New Directional Ramps or Equivalent.

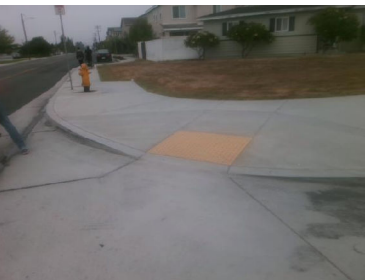
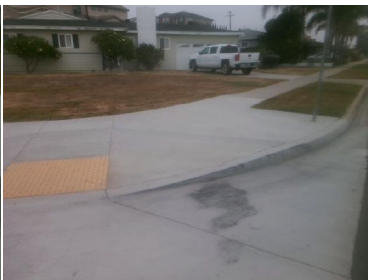
| Compliance | Description | Data | Compliance | Description | Data |
|---|---|---|---|---|---|
| Yes | Gutter Ponding | No | No | Curb Slope | 10.6 |
| Yes | Overall Surface Condition: Acceptable | | Yes | Perp Joint Present | Yes |
