# Access Compliance Report Public Rights-of-Way (Curb Ramps)

Main Street: AMIES\_RD Cross Street: HARRIET\_LN Location: SW

ADA ID: RPRK210924114747 Ramp Type: Type 1 - Perpendicular Diagonal Initial Pass/Fail: Fail Overall Compliance: No Severity Score: 32

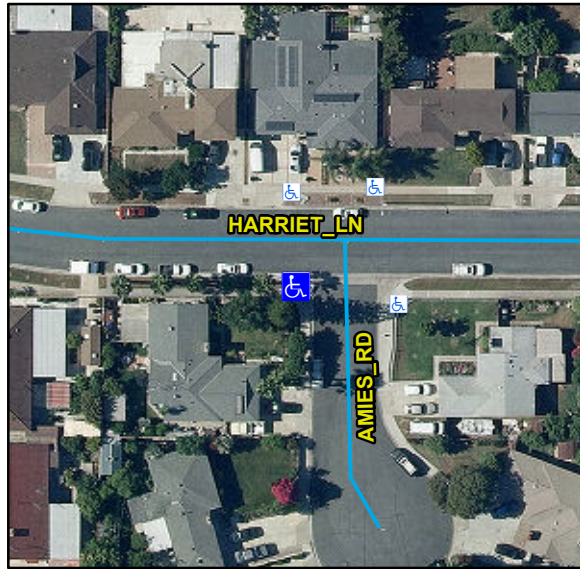
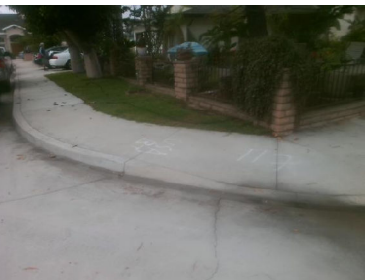
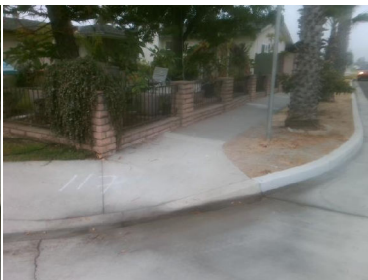
| Compliance | Description | Data | Compliance | Description | Data |
|---|---|---|---|---|---|
| No | Ramp Run Slope (%) | 13.7 | N/A | Flare Slope LT (%) | N/A |
| No | Ramp Cross Slope (%) | 3.7 | N/A | Flare Traversable LT | N/A |

Remove & Replace Curb Ramp With Two New Directional Ramps or Equivalent.
