# Access Compliance Report Public Rights-of-Way (Curb Ramps)

Main Street: HARRIET\_LN Cross Street: AMIES\_RD Location: SE

ADA ID: RPRK210924115048 Ramp Type: Type 1 - Perpendicular Diagonal Initial Pass/Fail: Fail Overall Compliance: No Severity Score: 16

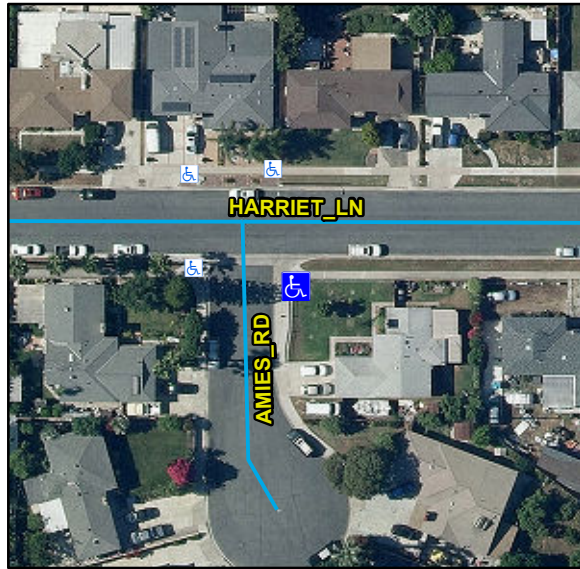
| Compliance | Description | Data | Compliance | Description | Data |
|---|---|---|---|---|---|
| No | Ramp Run Slope (%) | 10 | N/A | Flare Slope LT (%) | N/A |

Remove & Replace Curb Ramp With Two New Directional Ramps or Equivalent.

R304.2.2, STD 1115
