# Access Compliance Report Public Rights-of-Way (Curb Ramps)

Main Street: LARRY\_DR Cross Street: HARRIET\_LN Location: SW

ADA ID: RPRK210924115505 Ramp Type: Type 1 - Perpendicular Diagonal Initial Pass/Fail: Fail Overall Compliance: No Severity Score: 15

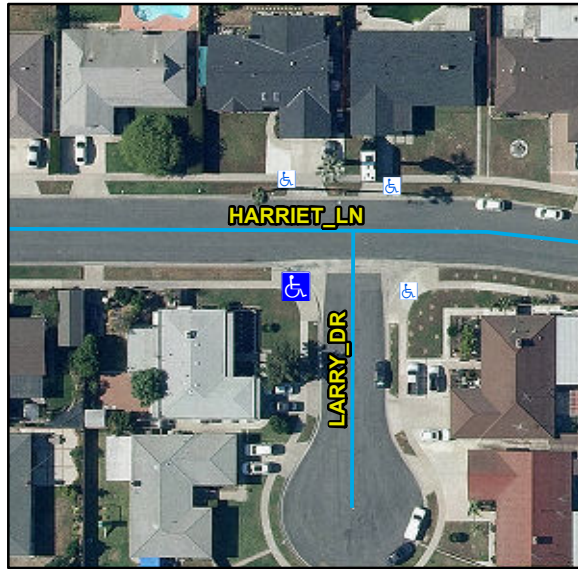
| Compliance | Description | Data | Compliance | Description | Data |
|---|---|---|---|---|---|
| No | Ramp Run Slope (%) | 8.6 | N/A | Flare Slope LT (%) | N/A |

**Remove & Replace Curb Ramp With Two New Directional Ramps or Equivalent.**

**R304.2.2, STD 1115**
