# Access Compliance Report Public Rights-of-Way (Curb Ramps)

Main Street: HARRIET\_LN Cross Street: LARRY\_DR Location: SE

ADA ID: RPRK210924115738 Ramp Type: Type 1 - Perpendicular Diagonal Initial Pass/Fail: Pass Overall Compliance: No Severity Score: 20

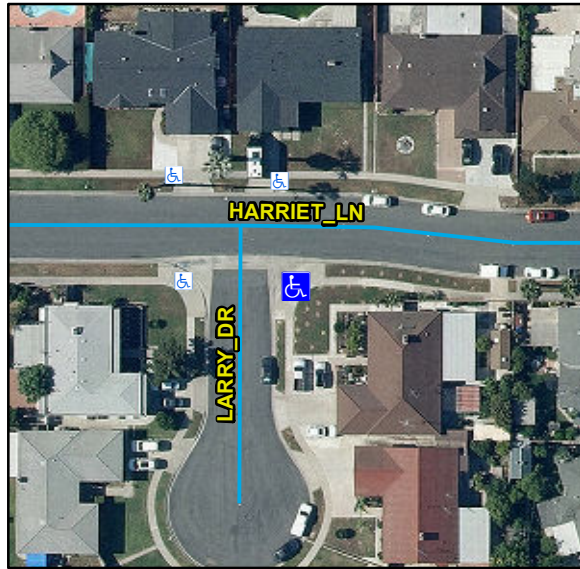
R304.2.2, R304.2.1, R304.2.2-Perp, R304.3.2-Para, R304.5.3, R305, STD 1115

| Compliance | Description | Data | Compliance | Description | Data |
|---|---|---|---|---|---|
| No | Landing Width (in) | N/A | Yes | Flare Slope RT (%) | 4 |
| No | Landing Run Slope (%) | N/A | N/A | Flare Traversable RT | Yes |
| No | Landing Cross Slope (%) | N/A | No | DWS Provided | No |
| Yes | Gutter Ponding | No | No | Curb Slope | 8.8 |

Remove & Replace Curb Ramp With Two New Directional Ramps or Equivalent.
