# Access Compliance Report Public Rights-of-Way (Curb Ramps)

Main Street: HARRIET\_LN Cross Street: PATRICIA\_DR Location: SE

ADA ID: RPRK210924120237 Ramp Type: Type 1 - Perpendicular Diagonal Initial Pass/Fail: Fail Overall Compliance: No Severity Score: 2

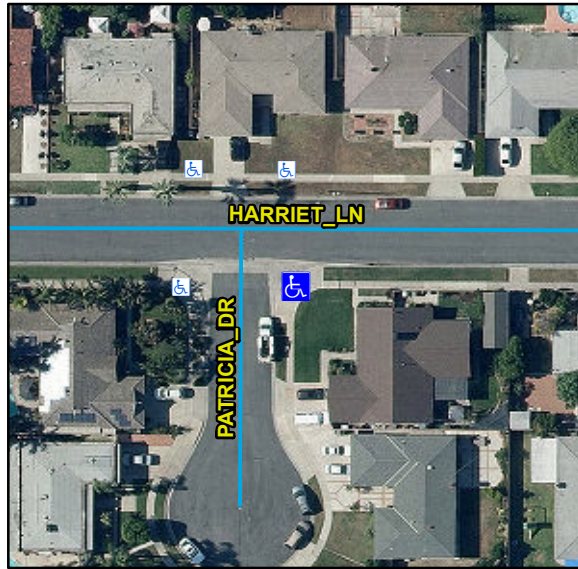
| Compliance | Description | Data | Compliance | Description | Data |
|---|---|---|---|---|---|
| No | Ramp Cross Slope (%) | 2.3 | N/A | Flare Traversable LT | N/A |
| N/A | Gutter Ponding | N/A | No | Curb Slope | 7.6 |

**Remove & Replace Curb Ramp With Two New Directional Ramps or Equivalent.**

**R304.2.2, R304.5.3, STD 1115**
