# Access Compliance Report Public Rights-of-Way (Curb Ramps)

Main Street: PATRICIA\_DR Cross Street: HARRIET\_LN Location: SW

ADA ID: RPRK210924120526 Ramp Type: Type 1 - Perpendicular Diagonal Initial Pass/Fail: Pass Overall Compliance: No Severity Score: 22

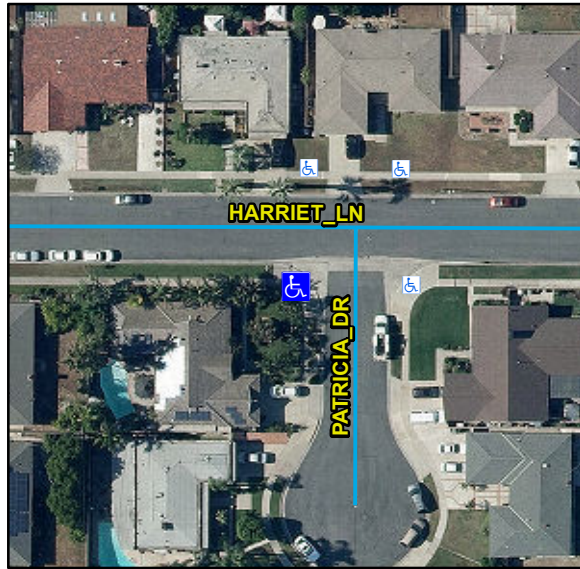
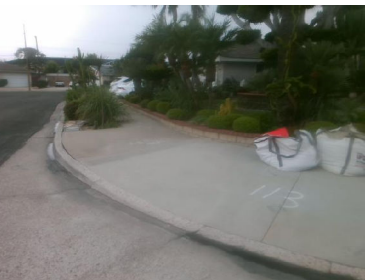
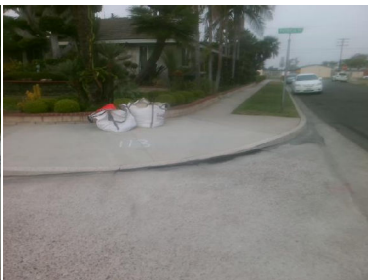
| Compliance | Description | Data | Compliance | Description | Data |
|---|---|---|---|---|---|
| No | Landing Width (in) | N/A | Yes | Flare Slope RT (%) | 4.8 |
| No | Landing Run Slope (%) | N/A | N/A | Flare Traversable RT | Yes |
| No | Landing Cross Slope (%) | N/A | No | DWS Provided | No |
| No | Gutter Ponding | Yes | No | Curb Slope | 10 |

**Remove & Replace Curb Ramp With Two New Directional Ramps or Equivalent.**
