# Access Compliance Report Public Rights-of-Way (Curb Ramps)

| Main Street: GILBERT_ST | | Cross Street: GUINIDA_LN | | Location: | NW |
| ADA ID: RPRK210924122212 | Ramp Type: Type 4 - Parallel | Initial Pass/Fail: Fail | Overall Compliance: No | Severity Score: | 2 |

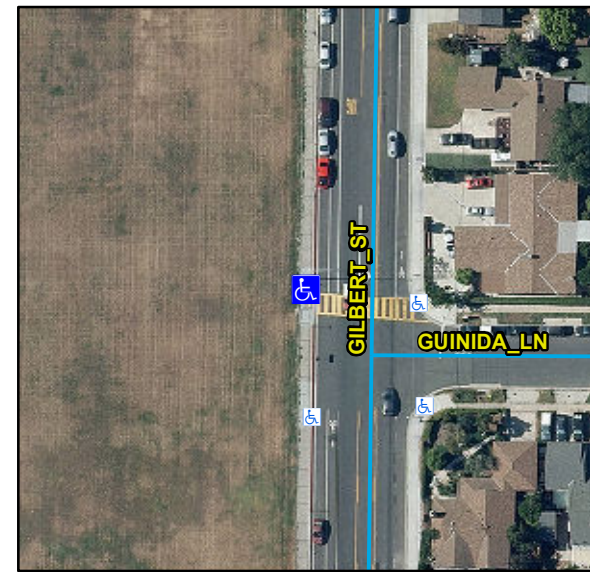
| Compliance | Description | Data | Compliance | Description | Data |
|---|---|---|---|---|---|
| No | Ramp Cross Slope LT (%) | 4.2 | Yes | Ramp Cross Slope RT (%) | 0.9 |

Possible Solutions:

Remove & Replace Entire Ramp.

R304.5.3, STD 1115

\$ 2000
