# Access Compliance Report Public Rights-of-Way (Curb Ramps)

Main Street: MILNEBURG\_ST Cross Street: KENNELLY\_LN Location: NE

ADA ID: RPRK210924125317 Ramp Type: Type 1 - Perpendicular Diagonal Initial Pass/Fail: Fail Overall Compliance: No Severity Score: 32

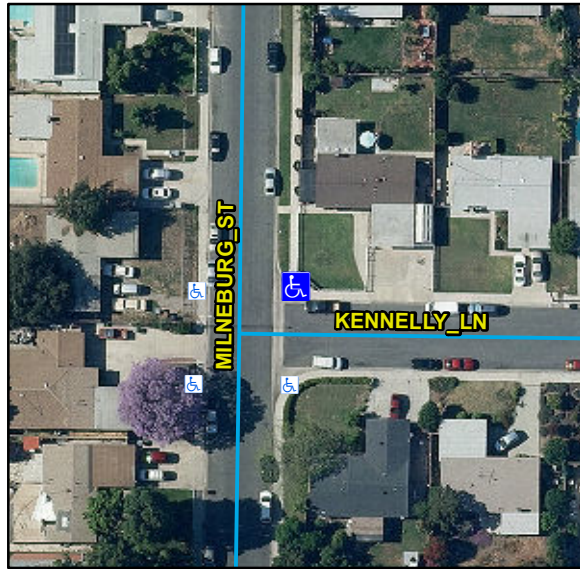
| Compliance | Description | Data | Compliance | Description | Data |
|---|---|---|---|---|---|
| No | Ramp Run Slope (%) | 13.2 | N/A | Flare Slope LT (%) | N/A |

Remove & Replace Curb Ramp With Two New Directional Ramps or Equivalent.

R304.2.2, STD 1115
