# Access Compliance Report Public Rights-of-Way (Curb Ramps)

Main Street: KENNELLY\_LN Cross Street: MILNEBURG\_ST Location: SE

ADA ID: RPRK210924125559 Ramp Type: Type 1 - Perpendicular Diagonal Initial Pass/Fail: Fail Overall Compliance: No Severity Score: 30

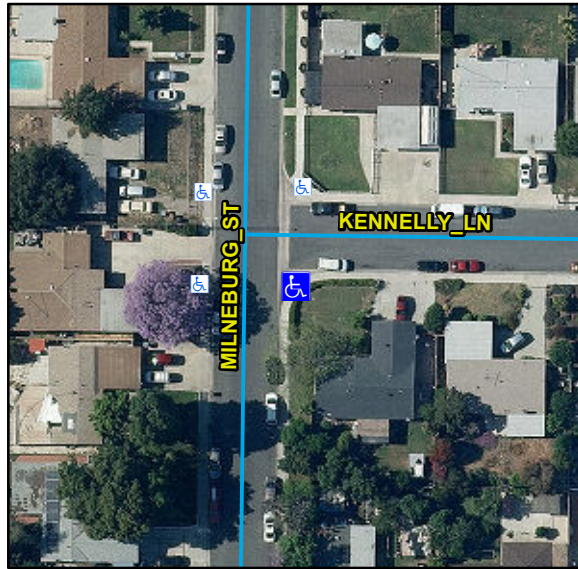
| Compliance | Description | Data | Compliance | Description | Data |
|---|---|---|---|---|---|
| No | Ramp Run Slope (%) | 12.3 | N/A | Flare Slope LT (%) | N/A |

Remove & Replace Curb Ramp With Two New Directional Ramps or Equivalent.

R304.2.2, STD 1115
