# Access Compliance Report Public Rights-of-Way (Curb Ramps)

Main Street: THISTLE\_RD Cross Street: THISTLE\_RD Location: NW

ADA ID: RPRK210924145808 Ramp Type: Type 6 - Directional 1 Initial Pass/Fail: Pass Overall Compliance: No Severity Score: 0

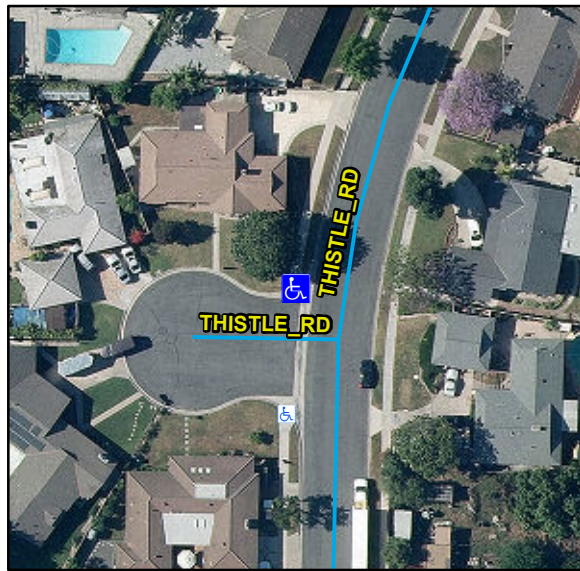
R304.5.2, STD 1115

| Compliance | Description | Data | Compliance | Description | Data |
|---|---|---|---|---|---|
| No | Grade Break | No | N/A | Flare Type RT | |

Remove & Replace Entire Ramp.

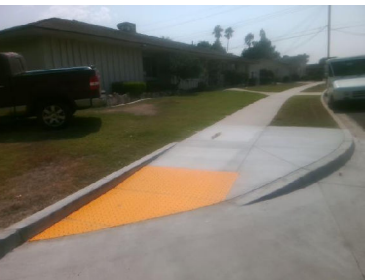
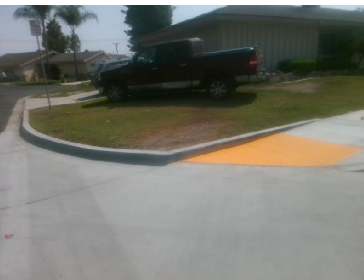
| Compliance | Description | Data | Compliance | Description | Data |
|---|---|---|---|---|---|
| Yes | Overall Surface Condition | Acceptable | Yes | Perp Joint Present | Yes |

\$ 531
