# Access Compliance Report Public Rights-of-Way (Curb Ramps)

**Main Street:** THISTLE\_RD      **Cross Street:** RAMM\_DR      **Location:** N

**ADA ID:** RPRK210924172140      **Ramp Type:** Type 6 - Directional 1      **Initial Pass/Fail:** Fail      **Overall Compliance:** No      **Severity Score:** 2

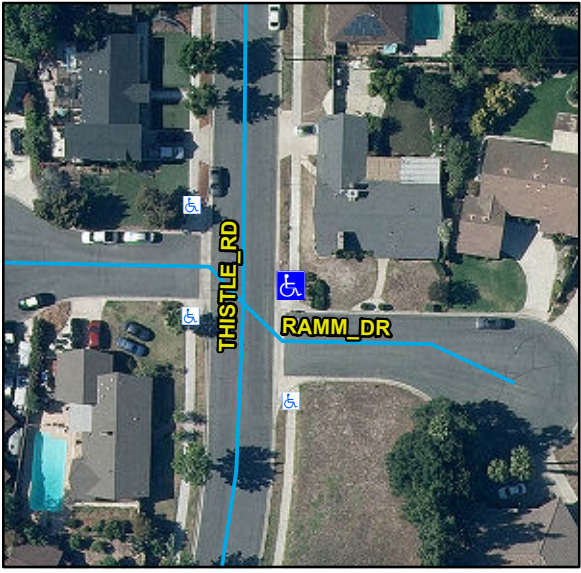
Compliance	Description	Data	Compliance	Description	Data
N/A	Ramp Length (in)	103	N/A	Flare Type LT	
Yes	Ramp Width (in)	60			N/A
Yes	Ramp Run Slope (%)	5.6	N/A	Flare Slope LT (%)	N/A
No	Ramp Cross Slope (%)	4	N/A	Flare Traversable LT	N/A
N/A	Grade Break	N/A	N/A	Flare Type RT	
N/A	Grade Break Slope (%)	N/A			N/A
N/A	Grade Break Cross Slope (%)	N/A	N/A	Flare Slope RT (%)	N/A
	Addl Para Ramp Left?	No	N/A	Flare Traversable RT	N/A
	Addl Para Ramp Right?	No	N/A	DWS Provided	N/A
N/A	Landing Present	N/A	N/A	DWS Contrast	N/A
N/A	Landing Length (in)	N/A	N/A	DWS Length (in)	N/A
N/A	Landing Width (in)	N/A	N/A	DWS Full Width	N/A
N/A	Landing Run Slope (%)	N/A		DWS Offset Type	N/A
N/A	Landing Cross Slope (%)	N/A	N/A	DWS Left Offset (in)	N/A
N/A	Landing Movement Obstructed?	N/A	N/A	DWS Right Offset (in)	N/A
	Landing Movement Type	N/A			
N/A	Landing Shared	N/A			
N/A	Marked Crosswalk 1	No	N/A	Clear Space	Yes
	Crossing 1 Direction	W	N/A	Clear Space To Crosswalk (in)	N/A

Marked Crosswalk 1 Width (in)	N/A			
N/A	Ramp Inside Crosswalk 1	N/A			
	Crossing 1 Slope (%)	8.4			
	Crossing 1 Cross Slope (%)	1.5			
N/A	Gutter Ponding	N/A	N/A	Curb Slope	1
Yes	Gutter Lip Height (in)	0		Road Run Slope (%)	1
N/A	Gutter Run Slope (%)	N/A		Road Cross Slope (%)	0.8
N/A	Gutter Cross Slope (%)	N/A		Parallel Ramp Side	Left
Yes	Overall Surface Condition	Acceptable	Yes	Perp Joint Present	Yes
	Cross Gutter Present?	Yes		Spandrel Present?	Yes
	Replace Cross Gutter?	No		Replace Spandrel?	No

**Possible Solutions:**  
**Remove & Replace Curb Ramp With Two New Directional Ramps or Equivalent.**

**OC Std/PROW:**  
**R304.5.3, STD 1115**

**Total Cost:**      \$      **3080**
