# Access Compliance Report

## Public Rights-of-Way

### (Curb Ramps)

Main Street: THISTLE\_RD Cross Street: RAMM\_DR Location: W

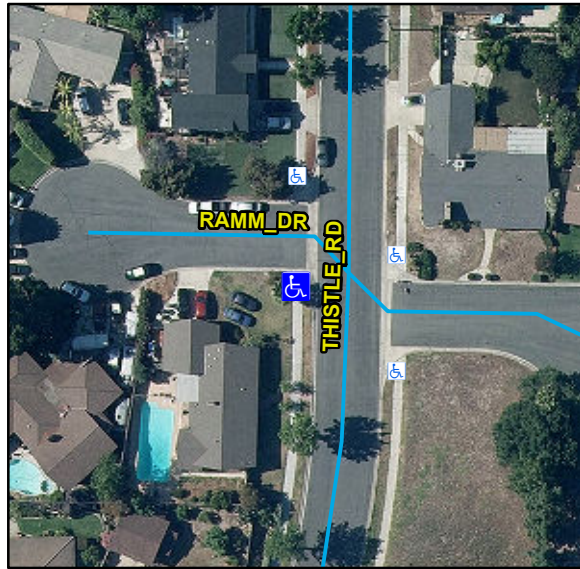
ADA ID: RPRK210924172927 Ramp Type: Type 6 - Directional 1 Initial Pass/Fail: Pass Overall Compliance: No Severity Score: 4

| Compliance | Description | Data | Compliance | Description | Data |
|---|---|---|---|---|---|
| Yes | Ramp Run Slope (%) | 2.4 | No | Flare Slope LT (%) | 11.5 |
| No | Landing Run Slope (%) | 2.5 | | DWS Offset Type | Single |

**Remove & Replace Curb Ramp With Two New Directional Ramps or Equivalent.**

**R304.2.2-Perp, R304.3.2-Para, R304.2.3, STD 1115**
