# Access Compliance Report Public Rights-of-Way (Curb Ramps)

| Main Street: THERESA_AVE | | Cross Street: THISTLE_RD | | Location: | N |
| ADA ID: RPRK210924173448 | Ramp Type: Type 6 - Directional 1 | Initial Pass/Fail: Pass | Overall Compliance: No | Severity Score: | 7 |

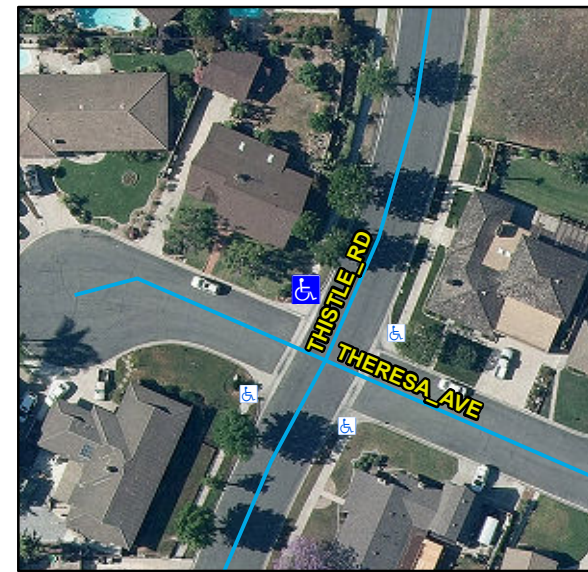
| Compliance | Description | Data | Compliance | Description | Data |
|---|---|---|---|---|---|
| No | Landing Run Slope (%) | 4.1 | | DWS Offset Type | Single |
| No | Gutter Run Slope (%) | 6.5 | | Road Cross Slope (%) | 7 |

Possible Solutions:

**Remove & Replace Landing. Remove & Replace Gutter.**
