# Access Compliance Report Public Rights-of-Way (Curb Ramps)

Main Street: THERESA\_AVE Cross Street: THISTLE\_RD Location: S

ADA ID: RPRK210924173848 Ramp Type: Type 6 - Directional 1 Initial Pass/Fail: Fail Overall Compliance: No Severity Score: 2

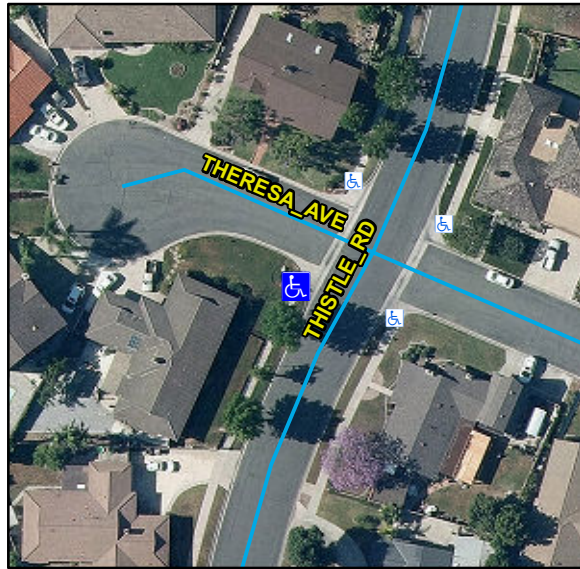
| Compliance | Description | Data | Compliance | Description | Data |
|---|---|---|---|---|---|
| No | Ramp Cross Slope (%) | 4 | N/A | Flare Traversable LT | N/A |

**Remove & Replace Curb Ramp With Two New Directional Ramps or Equivalent.**

**R304.5.3, STD 1115**
