# Access Compliance Report Public Rights-of-Way (Curb Ramps)

Main Street: THISTLE\_RD Cross Street: THERESA\_AVE Location: N

ADA ID: RPRK210924174125 Ramp Type: Type 6 - Directional 1 Initial Pass/Fail: Fail Overall Compliance: No Severity Score: 15

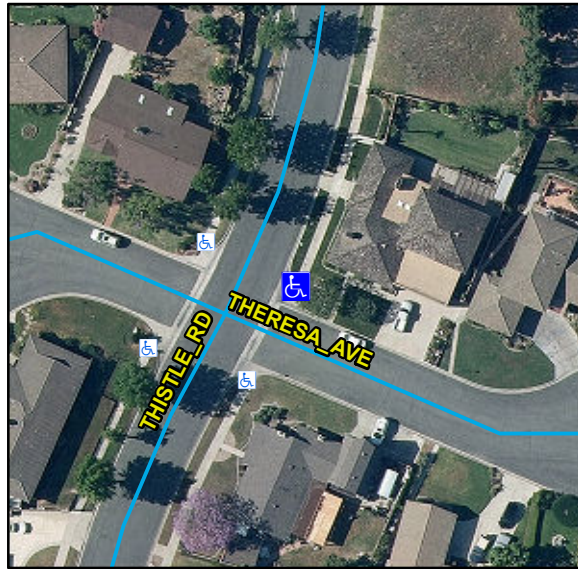
| Compliance | Description | Data | Compliance | Description | Data |
|---|---|---|---|---|---|
| No | Ramp Run Slope (%) | 8.8 | N/A | Flare Slope LT (%) | N/A |

Remove & Replace Curb Ramp With Two New Directional Ramps or Equivalent.

R304.2.2, STD 1115
