# Access Compliance Report Public Rights-of-Way (Curb Ramps)

Main Street: THERESA\_AVE Cross Street: THISTLE\_RD Location: S

ADA ID: RPRK210924174411 Ramp Type: Type 6 - Directional 1 Initial Pass/Fail: Pass Overall Compliance: No Severity Score: 6

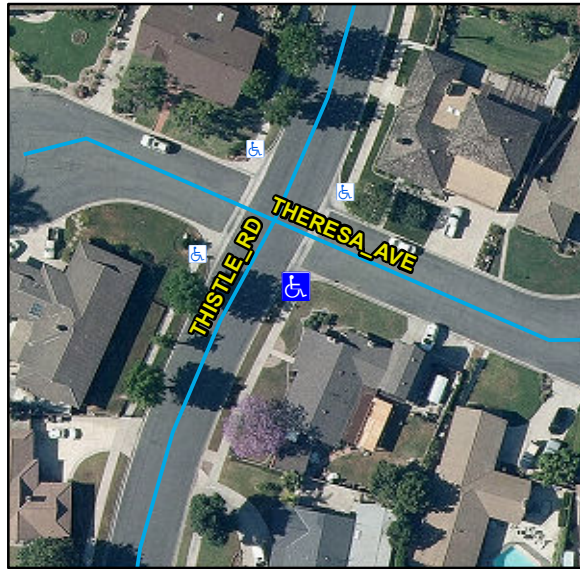
| Compliance | Description | Data | Compliance | Description | Data |
|---|---|---|---|---|---|
| N/A | Ramp Length (in) | 93 | No | Flare Type LT | |
| No | Landing Run Slope (%) | 3.1 | | DWS Offset Type | Single |
| No | Gutter Run Slope (%) | 5.4 | | Road Cross Slope (%) | 1.9 |

Remove & Replace Curb Ramp With Two New Directional Ramps or Equivalent. Remove & Replace Gutter.

R304.2.2-Perp, R304.3.2-Para, R304.2.3, R304.5.4, STD 1115
