Access Compliance Report Public Rights-of-Way (Curb Ramps)

Main Street: **ORANGE_AVE** Cross Street: **GILBERT_ST** Location: **NW**

ADA ID: **RPRK210927110852** Ramp Type: **Type 1 - Perpendicular Diagonal Initial Pass/Fail: Pass** Overall Compliance: **No** Severity Score: **0**

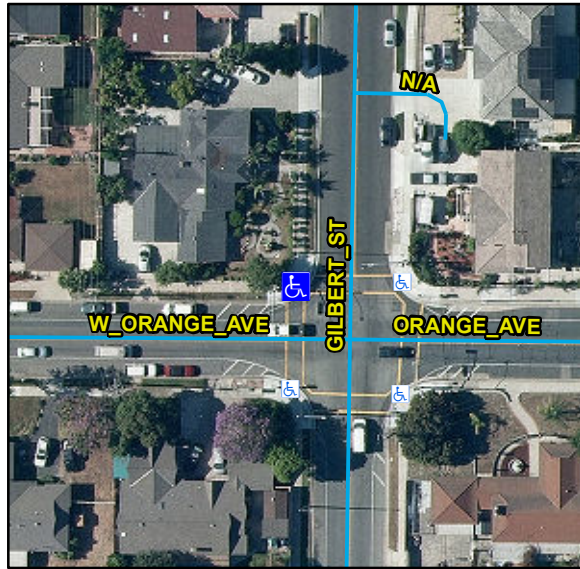
Possible Solutions:
Remove & Replace Landing. Gutter Ponding Observed.

Compliance	Description	Data	Compliance	Description	Data
N/A	Ramp Length (in)	109	N/A	Flare Type LT	
Yes	Ramp Width (in)	50			Sloped
Yes	Ramp Run Slope (%)	5.1	N/A	Flare Slope LT (%)	3.9
Yes	Ramp Cross Slope (%)	0	N/A	Flare Traversable LT	No
N/A	Landing Present	Yes	N/A	Flare Type RT	
N/A	Landing Length (in)	53			Sloped
Yes	Landing Width (in)	50	N/A	Flare Slope RT (%)	9
Yes	Landing Run Slope (%)	1.9	N/A	Flare Traversable RT	No
Yes	Landing Cross Slope (%)	0.6	Yes	DWS Provided	Yes
N/A	Landing Movement Obstructed?	Yes	Yes	DWS Contrast	Yes
	Landing Movement Type	Curb	Yes	DWS Length (in)	37
N/A	Landing Shared	No	Yes	DWS Full Width	Yes
N/A	Clear Space	Yes	Yes	DWS Offset Left (in)	0
N/A	Clear Space To Crosswalk (in)	48	Yes	DWS Offset Right (in)	N/A
N/A	Marked Crosswalk 1	No	N/A	Marked Crosswalk 2	No
	Crossing 1 Direction	S		Crossing 2 Direction	E
	Marked Crosswalk 1 Width (in)	N/A		Marked Crosswalk 2 Width (in)	N/A

N/A	Ramp Inside Crosswalk 1	N/A	Yes	Ramp Inside Crosswalk 2	N/A
	Crossing 1 Slope (%)	1.8		Crossing 2 Slope (%)	3.3
	Crossing 1 Cross Slope (%)	10.1		Crossing 2 Cross Slope (%)	0.8
No	Gutter Ponding	Yes	Yes	Curb Slope	4.9
Yes	Gutter Lip Height (in)	0		Road Run Slope (%)	1.5
Yes	Gutter Run Slope (%)	1.7		Road Cross Slope (%)	3.7
Yes	Gutter Cross Slope (%)	1.3			
Yes	Overall Surface Condition: Acceptable		Yes	Perp Joint Present	Yes
	Cross Gutter Present?	No		Spandrel Present?	No
	Replace Cross Gutter?	N/A		Replace Spandrel?	N/A
