# Access Compliance Report Public Rights-of-Way (Curb Ramps)

Main Street: GILBERT\_ST Cross Street: W\_ORANGE\_AVE Location: SW

ADA ID: RPRK210927112549 Ramp Type: Type 1 - Perpendicular Diagonal Initial Pass/Fail: Fail Overall Compliance: No Severity Score: 15

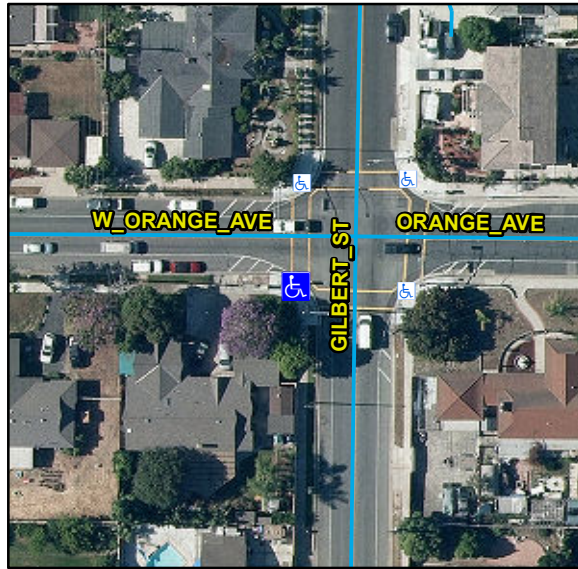
| Compliance | Description | Data | Compliance | Description | Data |
|---|---|---|---|---|---|
| No | Ramp Run Slope (%) | 10.9 | N/A | Flare Slope LT (%) | N/A |

Remove & Replace Curb Ramp With Two New Directional Ramps or Equivalent.
