# Access Compliance Report Public Rights-of-Way (Curb Ramps)

Main Street: ORANGE\_AVE Cross Street: GILBERT\_ST Location: SE

ADA ID: RPRK210927113429 Ramp Type: Type 1 - Perpendicular Diagonal Initial Pass/Fail: Fail Overall Compliance: No Severity Score: 15

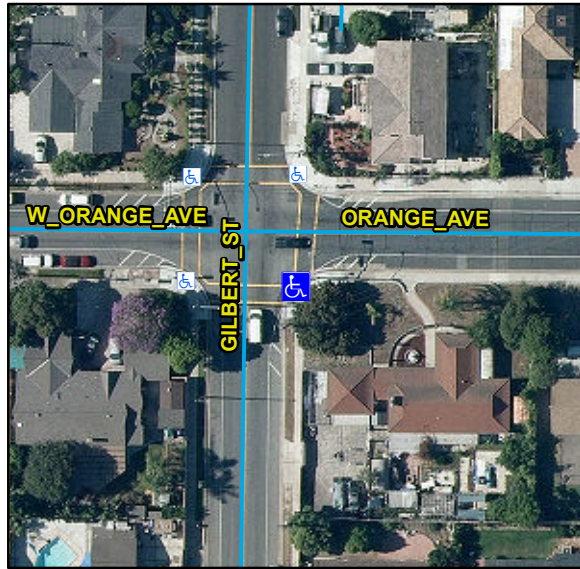
| Compliance | Description | Data | Compliance | Description | Data |
|---|---|---|---|---|---|
| No | Ramp Run Slope (%) | 10.6 | N/A | Flare Slope LT (%) | N/A |

Remove & Replace Curb Ramp With Two New Directional Ramps or Equivalent.

R304.2.2, STD 1115
