# Access Compliance Report Public Rights-of-Way (Curb Ramps)

Main Street: GILBERT\_ST Cross Street: ORANGE\_AVE Location: NE

ADA ID: RPRK210927114053 Ramp Type: Type 1 - Perpendicular Diagonal Initial Pass/Fail: Pass Overall Compliance: No Severity Score: 0

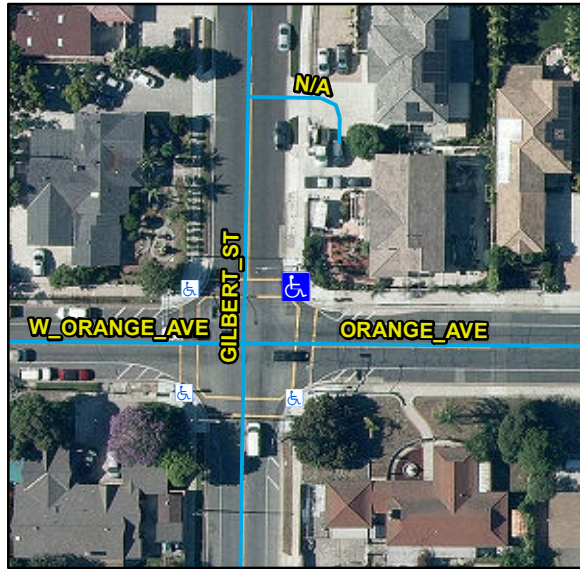
| Compliance | Description | Data | Compliance | Description | Data |
|---|---|---|---|---|---|
| No | Landing Cross Slope (%) | 3.7 | Yes | DWS Provided | Yes |
| No | Gutter Cross Slope (%) | 8.4 | | | |

Remove & Replace Landing. Remove & Replace Gutter.
