# Access Compliance Report Public Rights-of-Way (Curb Ramps)

Main Street: ORANGE\_AVE Cross Street: HILLVIEW\_RD Location: N

ADA ID: RPRK210927114649 Ramp Type: Type 1 - Perpendicular Diagonal Initial Pass/Fail: Fail Overall Compliance: No Severity Score: 2

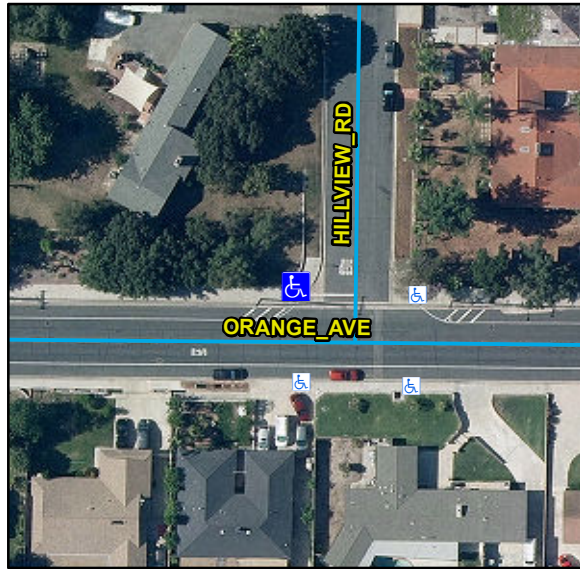
| Compliance | Description | Data | Compliance | Description | Data |
|---|---|---|---|---|---|
| No | Ramp Cross Slope (%) | 2.5 | N/A | Flare Traversable LT | N/A |

**Remove & Replace Curb Ramp With Two New Directional Ramps or Equivalent.**

**R304.5.3, STD 1115**
