# Access Compliance Report Public Rights-of-Way (Curb Ramps)

Main Street: ROSEBAY\_ST Cross Street: ORANGE\_AVE Location: SW

ADA ID: RPRK210927120044 Ramp Type: Type 1 - Perpendicular Diagonal Initial Pass/Fail: Fail Overall Compliance: No Severity Score: 2

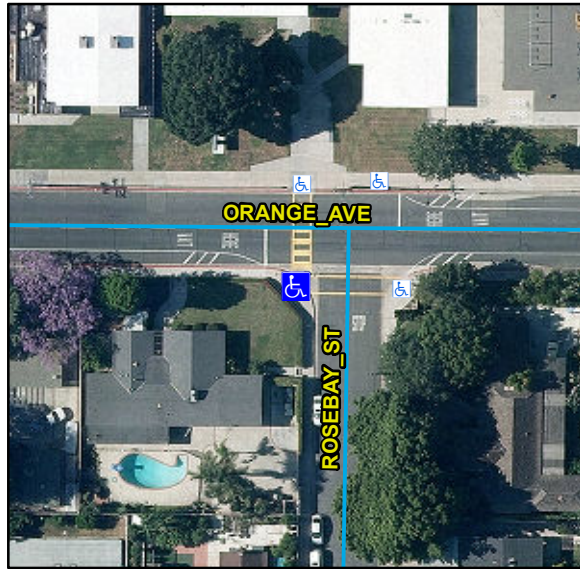
| Compliance | Description | Data | Compliance | Description | Data |
|---|---|---|---|---|---|
| No | Ramp Cross Slope (%) | 3.1 | N/A | Flare Traversable LT | N/A |

**Remove & Replace Curb Ramp With Two New Directional Ramps or Equivalent.**

**R304.5.3, STD 1115**
