# Access Compliance Report Public Rights-of-Way (Curb Ramps)

Main Street: ORANGE\_AVE Cross Street: ROSEBAY\_ST Location: SE

ADA ID: RPRK210927120340 Ramp Type: Type 1 - Perpendicular Diagonal Initial Pass/Fail: Fail Overall Compliance: No Severity Score: 2

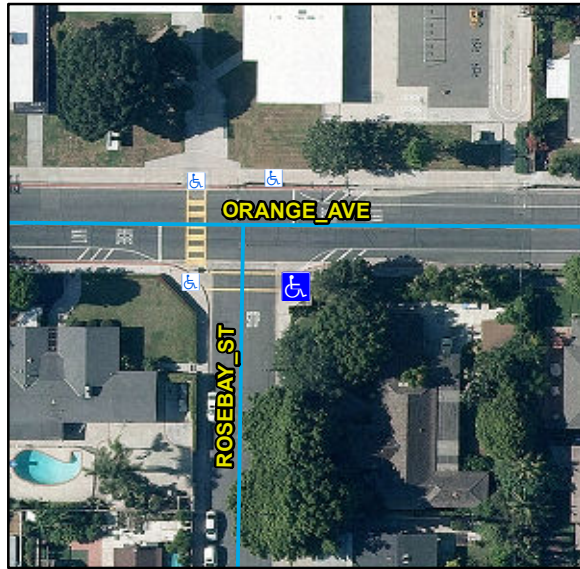
| Compliance | Description | Data | Compliance | Description | Data |
|---|---|---|---|---|---|
| No | Ramp Cross Slope (%) | 3.8 | N/A | Flare Traversable LT | N/A |

**Remove & Replace Curb Ramp With Two New Directional Ramps or Equivalent.**

**R304.5.3, STD 1115**

Total Cost: \$ 6160
