# Access Compliance Report Public Rights-of-Way (Curb Ramps)

Main Street: S\_BROOKHURST\_ST Cross Street: ORANGE\_AVE Location: SW

ADA ID: RPRK210927121809 Ramp Type: Type 1 - Perpendicular Diagonal Initial Pass/Fail: Pass Overall Compliance: No Severity Score: 10

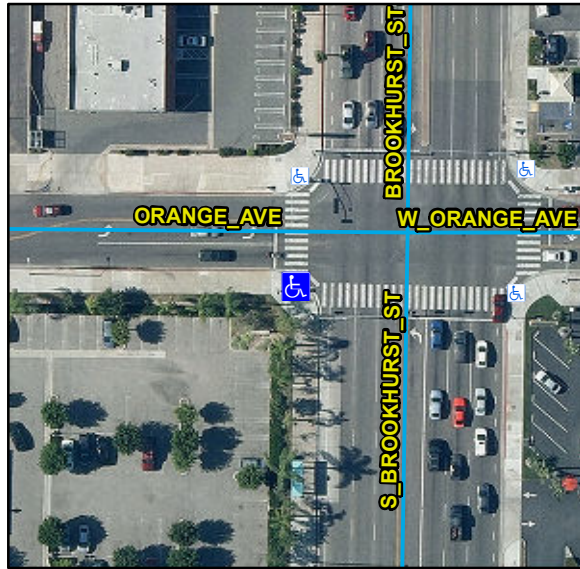
| Compliance | Description | Data | Compliance | Description | Data |
|---|---|---|---|---|---|
| No | Landing Run Slope (%) | 5.1 | N/A | Flare Traversable RT | Yes |
| No | Landing Cross Slope (%) | 3 | Yes | DWS Provided | Yes |
| No | Gutter Run Slope (%) | 6.1 | | Road Cross Slope (%) | 7 |
| No | Gutter Cross Slope (%) | 3.2 | | | |

Remove & Replace Landing. Remove & Replace Gutter.
