# Access Compliance Report Public Rights-of-Way (Curb Ramps)

Main Street: ORANGE\_AVE Cross Street: BROOKHURST\_ST Location: NW

ADA ID: RPRK210927122534 Ramp Type: Type 1 - Perpendicular Diagonal Initial Pass/Fail: Pass Overall Compliance: No Severity Score: 0

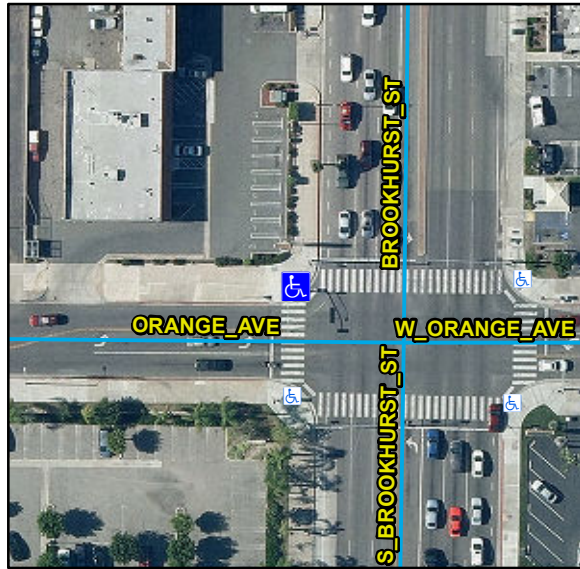
| Compliance | Description | Data | Compliance | Description | Data |
|---|---|---|---|---|---|
| No | Landing Run Slope (%) | 2.7 | N/A | Flare Traversable RT | No |
| No | Gutter Cross Slope (%) | 7.6 | | | |

Remove & Replace Landing. Remove & Replace Gutter.
