| Main Street: STONYBROOK_DR | | Cross Street: S_BROOKHURST_ST | | Location: | NW |

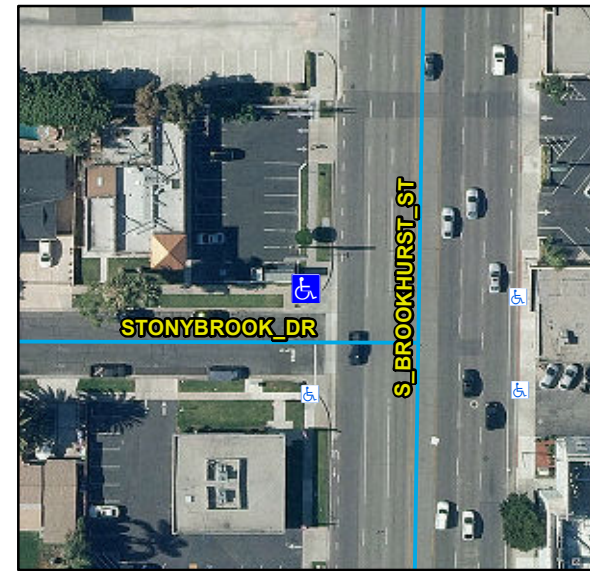
| ADA ID: RPRK210927123440 | Ramp Type: Type 1 - Perpendicular Diagonal Initial Pass/Fail: Fail | | Overall Compliance: No | | Severity Score: 2 |

| Compliance | Description | Data | Compliance | Description | Data |
|---|---|---|---|---|---|
| No | Ramp Cross Slope (%) | 4.9 | N/A | Flare Traversable LT | N/A |

**Remove & Replace Curb Ramp With Two New Directional Ramps or Equivalent.**

**R304.5.3, STD 1115**
