# Access Compliance Report Public Rights-of-Way (Curb Ramps)

Main Street: S\_BROOKHURST\_ST Cross Street: STONYBROOK\_DR Location: SW

ADA ID: RPRK210927123718 Ramp Type: Type 1 - Perpendicular Diagonal Initial Pass/Fail: Pass Overall Compliance: No Severity Score: 4

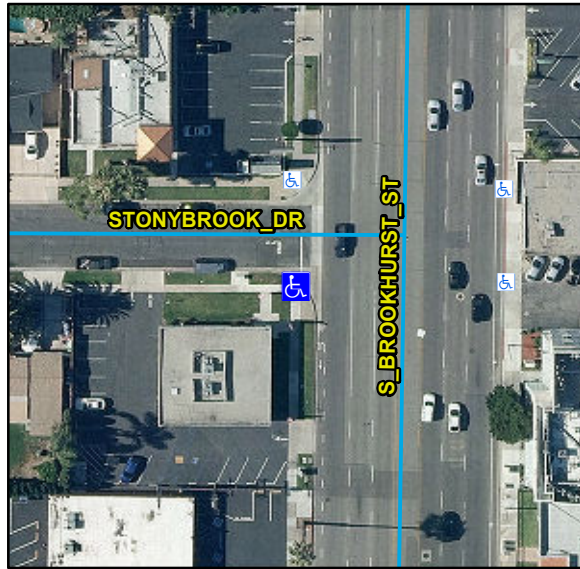
| Compliance | Description | Data | Compliance | Description | Data |
|---|---|---|---|---|---|
| No | Landing Cross Slope (%) | 2.1 | Yes | DWS Provided | Yes |
| No | Gutter Cross Slope (%) | 3.2 | | | |

Remove & Replace Landing. Remove & Replace Gutter.

R304.2.1, R304.5.3, STD 1115
