# Access Compliance Report Public Rights-of-Way (Curb Ramps)

Main Street: GILBERT\_ST Cross Street: RANDOM\_DR Location: NE

ADA ID: RPRK210927134232 Ramp Type: Type 6 - Directional 1 Initial Pass/Fail: Pass Overall Compliance: No Severity Score: 0

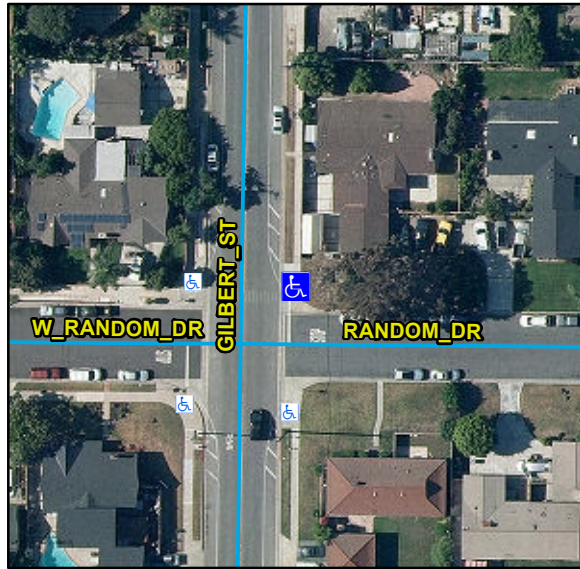
| Compliance | Description | Data | Compliance | Description | Data |
|---|---|---|---|---|---|
| No | Grade Break | No | Yes | Flare Type RT | |
| No | Gutter Cross Slope (%) | 4.2 | | Parallel Ramp Side | Right |

Remove & Replace Curb Ramp With Two New Directional Ramps or Equivalent. Remove & Replace Gutter.

R204.3, R304.5.2, R304.5.3, STD 1115
