# Access Compliance Report Public Rights-of-Way (Curb Ramps)

Main Street: RANDOM\_DR Cross Street: GILBERT\_ST Location: SE

ADA ID: RPRK210927134821 Ramp Type: Type 7 - Directional 2 Initial Pass/Fail: Fail Overall Compliance: No Severity Score: 2

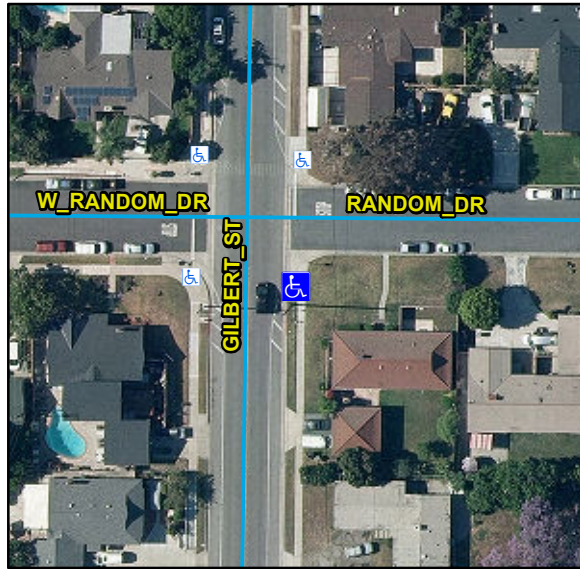
| Compliance | Description | Data | Compliance | Description | Data |
|---|---|---|---|---|---|
| No | Ramp Cross Slope (%) | 3.7 | N/A | Flare Traversable LT | N/A |

**Remove & Replace Curb Ramp With Two New Directional Ramps or Equivalent.**

**R204.3, R304.5.3, STD 1115**
