# Access Compliance Report Public Rights-of-Way (Curb Ramps)

Main Street: GILBERT\_ST Cross Street: W\_RANDOM\_DR Location: SW

ADA ID: RPRK210927135109 Ramp Type: Type 1 - Perpendicular Diagonal Initial Pass/Fail: Fail Overall Compliance: No Severity Score: 2

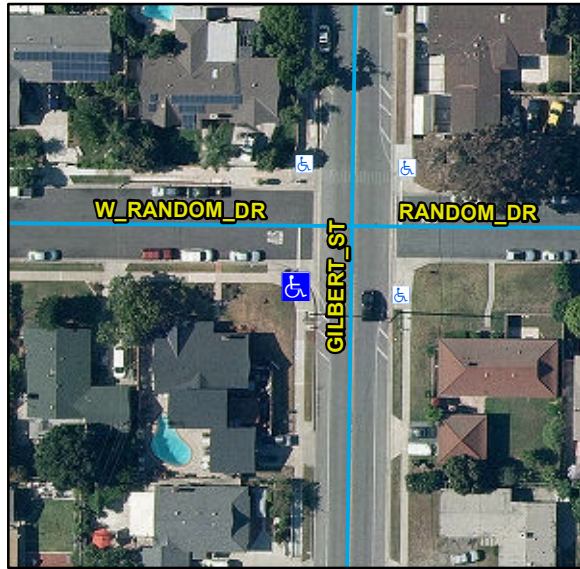
| Compliance | Description | Data | Compliance | Description | Data |
|---|---|---|---|---|---|
| No | Ramp Cross Slope (%) | 2.6 | N/A | Flare Traversable LT | N/A |
| No | Gutter Lip Height (in) | 0.5 | | Road Run Slope (%) | 4 |

Remove & Replace Curb Ramp With Two New Directional Ramps or Equivalent. Grind Gutter Lip.
