# Access Compliance Report Public Rights-of-Way (Curb Ramps)

Main Street: W\_RANDOM\_DR Cross Street: GILBERT\_ST Location: NW

ADA ID: RPRK210927135322 Ramp Type: Type 1 - Perpendicular Diagonal Initial Pass/Fail: Fail Overall Compliance: No Severity Score: 16

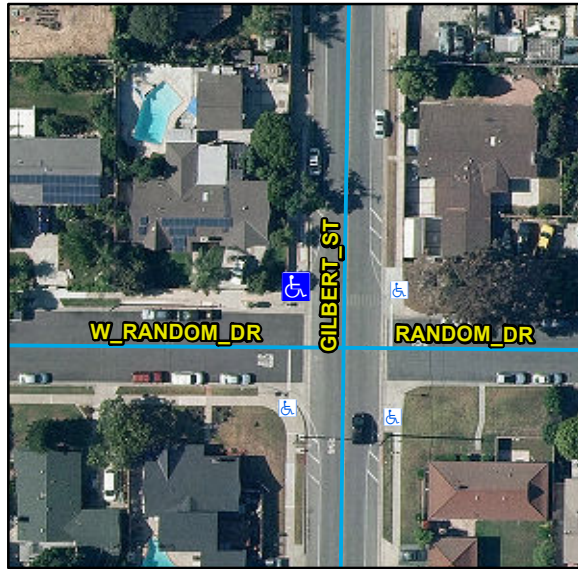
| Compliance | Description | Data | Compliance | Description | Data |
|---|---|---|---|---|---|
| No | Ramp Run Slope (%) | 11.4 | N/A | Flare Slope LT (%) | N/A |
| No | Ramp Cross Slope (%) | 3.1 | N/A | Flare Traversable LT | N/A |
| No | Gutter Lip Height (in) | 0.5 | | Road Run Slope (%) | 3.6 |

**Remove & Replace Curb Ramp With Two New Directional Ramps or Equivalent. Grind Gutter Lip.**

**R204.3, R304.2.2, R304.5.3, R302.7.2, STD 1115**
