# Access Compliance Report Public Rights-of-Way (Curb Ramps)

Main Street: STONYBROOK\_DR Cross Street: S\_GILBERT\_ST Location: SE

ADA ID: RPRK210927135933 Ramp Type: Type 1 - Perpendicular Diagonal Initial Pass/Fail: Fail Overall Compliance: No Severity Score: 15

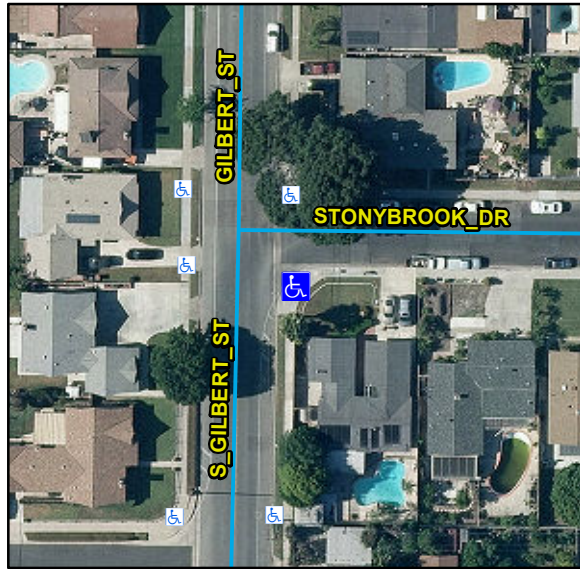
| Compliance | Description | Data | Compliance | Description | Data |
|---|---|---|---|---|---|
| No | Ramp Run Slope (%) | 10.9 | N/A | Flare Slope LT (%) | N/A |

Remove & Replace Curb Ramp With Two New Directional Ramps or Equivalent.

R204.3, R304.2.2, STD 1115
