# Access Compliance Report Public Rights-of-Way (Curb Ramps)

Main Street: S\_GILBERT\_ST Cross Street: STONYBROOK\_DR Location: SW

ADA ID: RPRK210927142732 Ramp Type: Type 1 - Perpendicular Diagonal Initial Pass/Fail: Fail Overall Compliance: No Severity Score: 32

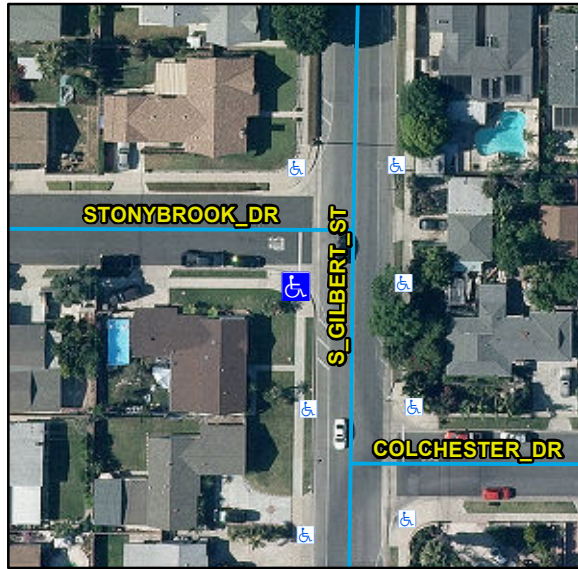
| Compliance | Description | Data | Compliance | Description | Data |
|---|---|---|---|---|---|
| No | Ramp Run Slope (%) | 12.8 | N/A | Flare Slope LT (%) | N/A |
| No | Ramp Cross Slope (%) | 2.2 | N/A | Flare Traversable LT | N/A |

**Remove & Replace Curb Ramp With Two New Directional Ramps or Equivalent.**

R304.2.2, R204.3, R304.5.3, STD 1115
