# Access Compliance Report Public Rights-of-Way (Curb Ramps)

Main Street: STONYBROOK\_DR Cross Street: S\_GILBERT\_ST Location: NW

ADA ID: RPRK210927142914 Ramp Type: Type 1 - Perpendicular Diagonal Initial Pass/Fail: Fail Overall Compliance: No Severity Score: 16

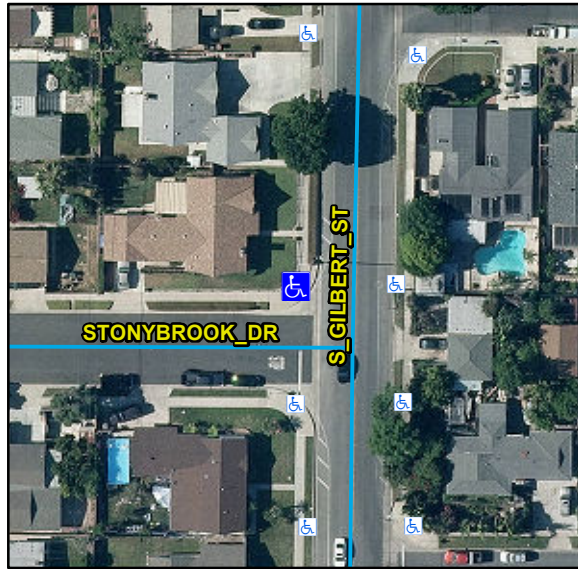
| Compliance | Description | Data | Compliance | Description | Data |
|---|---|---|---|---|---|
| No | Ramp Run Slope (%) | 11.6 | N/A | Flare Slope LT (%) | N/A |
| No | Ramp Cross Slope (%) | 4.7 | N/A | Flare Traversable LT | N/A |
| N/A | Gutter Ponding | N/A | No | Curb Slope | 11.7 |

**Remove & Replace Curb Ramp With Two New Directional Ramps or Equivalent.**

**R304.2.2, R204.3, R304.5.3, STD 1115**
