# Access Compliance Report Public Rights-of-Way (Curb Ramps)

Main Street: **S\_GILBERT\_ST** Cross Street: **COLCHESTER\_DR** Location: **NE**

ADA ID: **RPRK210927143212** Ramp Type: **Type 1 - Perpendicular Diagonal** Initial Pass/Fail: **Fail** Overall Compliance: **No** Severity Score: **16**

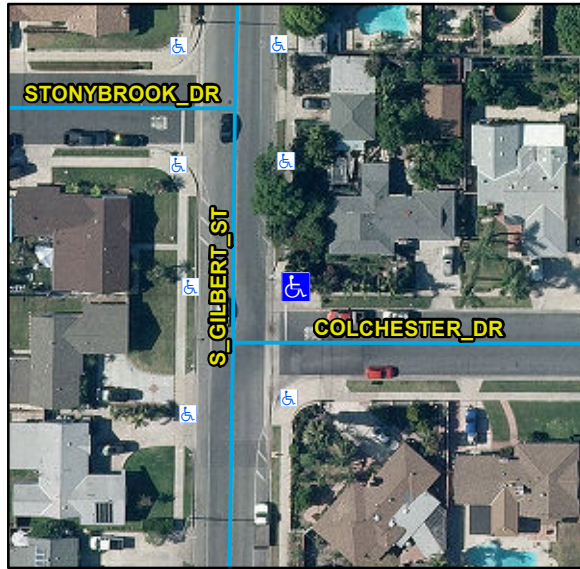
Compliance	Description	Data	Compliance	Description	Data
N/A	Ramp Length (in)	117	N/A	Flare Type LT	
Yes	Ramp Width (in)	48			N/A
No	Ramp Run Slope (%)	8.7	N/A	Flare Slope LT (%)	N/A
No	Ramp Cross Slope (%)	2.4	N/A	Flare Traversable LT	N/A
N/A	Landing Present	N/A	N/A	Flare Type RT	
N/A	Landing Length (in)	N/A			N/A
N/A	Landing Width (in)	N/A	N/A	Flare Slope RT (%)	N/A
N/A	Landing Run Slope (%)	N/A	N/A	Flare Traversable RT	N/A
N/A	Landing Cross Slope (%)	N/A	N/A	DWS Provided	N/A
N/A	Landing Movement Obstructed?	N/A	N/A	DWS Contrast	N/A
	Landing Movement Type	N/A	N/A	DWS Length (in)	N/A
N/A	Landing Shared	N/A	N/A	DWS Full Width	N/A
N/A	Clear Space	Yes	N/A	DWS Offset Left (in)	N/A
N/A	Clear Space To Crosswalk (in)	N/A	N/A	DWS Offset Right (in)	N/A
N/A	Marked Crosswalk 1	No	N/A	Marked Crosswalk 2	No
	Crossing 1 Direction	W		Crossing 2 Direction	S
	Marked Crosswalk 1 Width (in)	N/A		Marked Crosswalk 2 Width (in)	N/A

N/A	Ramp Inside Crosswalk 1	N/A	Yes	Ramp Inside Crosswalk 2	N/A
	Crossing 1 Slope (%)	3.3		Crossing 2 Slope (%)	1.7
	Crossing 1 Cross Slope (%)	0.3		Crossing 2 Cross Slope (%)	1.9
N/A	Gutter Ponding	N/A	No	Curb Slope	10.4
Yes	Gutter Lip Height (in)	0		Road Run Slope (%)	4.9
N/A	Gutter Run Slope (%)	N/A		Road Cross Slope (%)	7.5
N/A	Gutter Cross Slope (%)	N/A			
Yes	Overall Surface Condition: <b>Acceptable</b>		No	Perp Joint Present	No
	Cross Gutter Present?	Yes		Spandrel Present?	Yes
	Replace Cross Gutter?	No		Replace Spandrel?	No

Possible Solutions:  
**Remove & Replace Curb Ramp With Two New Directional Ramps or Equivalent.**

OC Std/PROW:  
**R304.2.2, R204.3, R304.5.3, STD 1115**
