# Access Compliance Report Public Rights-of-Way (Curb Ramps)

Main Street: HARVEST\_LN Cross Street: COLCHESTER\_DR Location: SW

ADA ID: RPRK210927144019 Ramp Type: Type 1 - Perpendicular Diagonal Initial Pass/Fail: Fail Overall Compliance: No Severity Score: 2

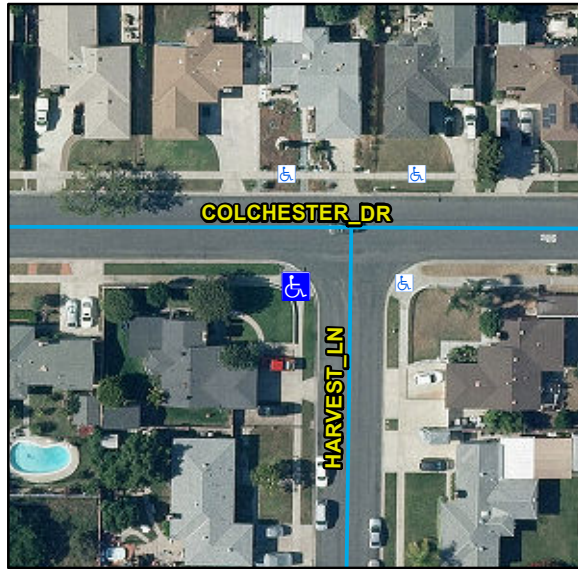
| Compliance | Description | Data | Compliance | Description | Data |
|---|---|---|---|---|---|
| No | Ramp Cross Slope (%) | 3.4 | N/A | Flare Traversable LT | N/A |

Remove & Replace Curb Ramp With Two New Directional Ramps or Equivalent.

R304.5.3, STD 1115
