# Access Compliance Report Public Rights-of-Way (Curb Ramps)

Main Street: COLCHESTER\_DR Cross Street: HARVEST\_LN Location: SE

ADA ID: RPRK210927144213 Ramp Type: Type 1 - Perpendicular Diagonal Initial Pass/Fail: Pass Overall Compliance: No Severity Score: 0

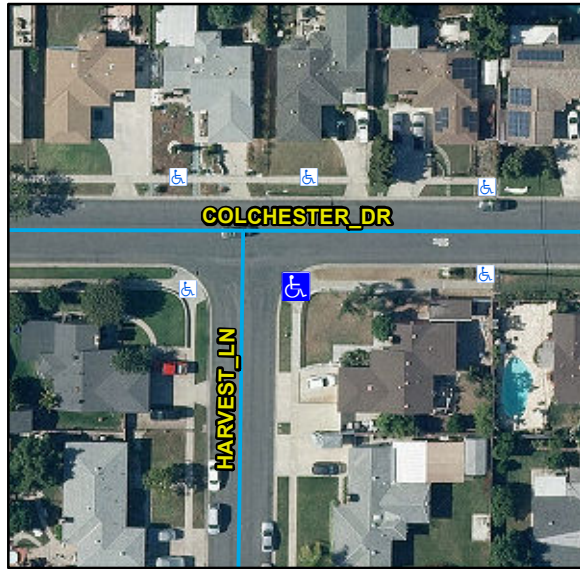
| Compliance | Description | Data | Compliance | Description | Data |
|---|---|---|---|---|---|
| No | Landing Run Slope (%) | 2.9 | N/A | Flare Traversable RT | Yes |

Remove & Replace Landing.

R304.2.1, R304.2.2-Perp, R304.3.2-Para, STD 1115

Total Cost: \$ 531
