# Access Compliance Report Public Rights-of-Way (Curb Ramps)

Main Street: YARDLEY\_ST Cross Street: BALL\_RD Location: SW

ADA ID: RPRK210927145734 Ramp Type: Type 7 - Directional 2 Initial Pass/Fail: Fail Overall Compliance: No Severity Score: 2

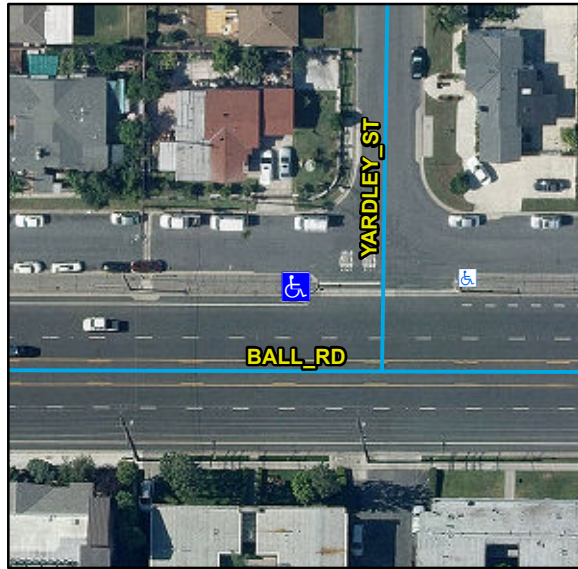
| Compliance | Description | Data | Compliance | Description | Data |
|---|---|---|---|---|---|
| No | Obstructions Present? | Yes | N/A | Utilities Present? | No |
| | Obstruction Types | Street Sign | | Utility Types | |

| Compliance | Description | Data | Compliance | Description | Data |
|---|---|---|---|---|---|
| No | Ramp Cross Slope (%) | 2.2 | N/A | Flare Traversable LT | N/A |

Remove & Replace Entire Ramp.

R204.3, R304.5.3, R302.3, R402.2, STD 1115
