# Access Compliance Report Public Rights-of-Way (Curb Ramps)

Main Street: YARDLEY\_ST Cross Street: BALL\_RD Location: SE

ADA ID: RPRK210927150129 Ramp Type: Type 7 - Directional 2 Initial Pass/Fail: Pass Overall Compliance: No Severity Score: 6

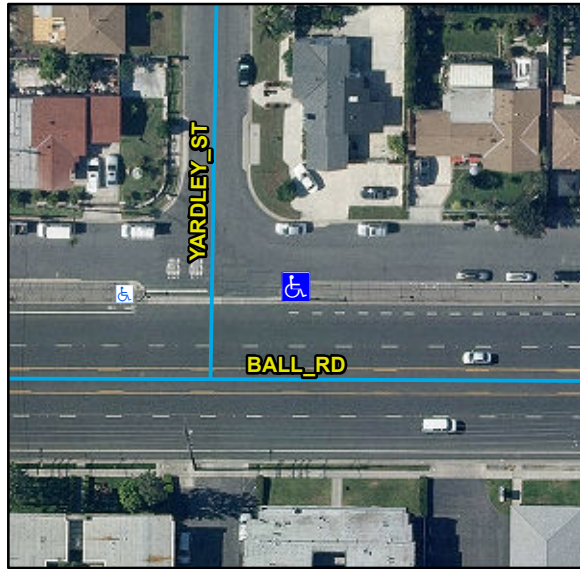
| Compliance | Description | Data | Compliance | Description | Data |
|---|---|---|---|---|---|
| No | Grade Break | No | No | Flare Type RT | |
| Yes | Landing Width (in) | 54 | No | DWS Full Width | No |
| No | Landing Cross Slope (%) | 4.1 | Yes | DWS Left Offset (in) | 0 |
| No | Gutter Cross Slope (%) | 7.8 | | Parallel Ramp Side | Right |

**Remove & Replace Entire Ramp. Remove & Replace Gutter.**

**R204.3, R304.5.3, R304.5.2, R304.2.3, R305.1.4, STD 1115**
