# Access Compliance Report Public Rights-of-Way (Curb Ramps)

| Main Street: BALL_RD | | Cross Street: HARVEST_LN | | Location: | SE |
| ADA ID: RPRK210927150636 | Ramp Type:Type 1 - Perpendicular | Initial Pass/Fail: Fail | Overall Compliance: No | Severity Score: | 2 |

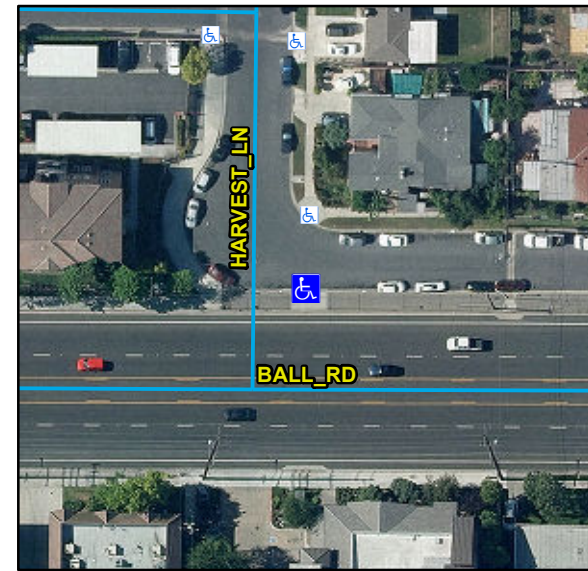
| Compliance | Description | Data | Compliance | Description | Data |
|---|---|---|---|---|---|
| No | Ramp Cross Slope (%) | 3.7 | N/A | Flare Traversable LT | N/A |
| N/A | Gutter Ponding | N/A | No | Curb Slope | 6.4 |

Remove & Replace Entire Ramp.

R304.2.2, R204.3, R304.5.3, STD 1115

\$ 4000
