# Access Compliance Report Public Rights-of-Way (Curb Ramps)

Main Street: HARVEST\_LN Cross Street: BALL\_RD Location: NE

ADA ID: RPRK210927150845 Ramp Type: Type 1 - Perpendicular Diagonal Initial Pass/Fail: Pass Overall Compliance: No Severity Score: 0

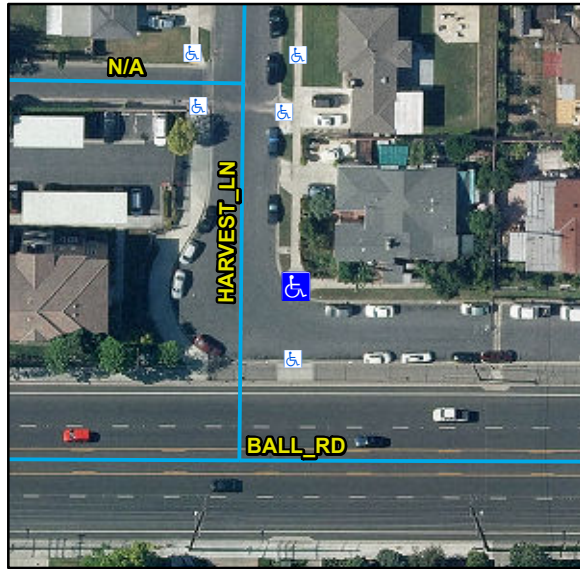
| Compliance | Description | Data | Compliance | Description | Data |
|---|---|---|---|---|---|
| Yes | Gutter Ponding | No | No | Curb Slope | 10.7 |

**Remove & Replace Curb Ramp With Two New Directional Ramps or Equivalent.**

R304.2.2, R304.2.1, STD 1115
