# Access Compliance Report Public Rights-of-Way (Curb Ramps)

Main Street: N/A Cross Street: HARVEST\_LN Location: SW

ADA ID: RPRK210927151302 Ramp Type: Type 1 - Perpendicular Initial Pass/Fail: Pass Overall Compliance: No Severity Score: 12

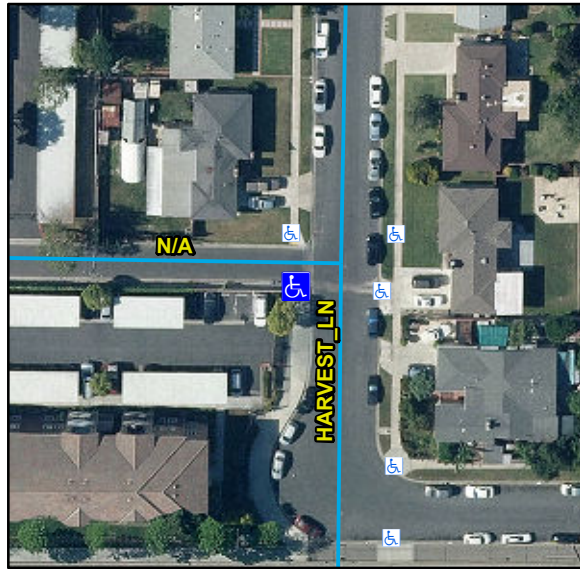
| Compliance | Description | Data | Compliance | Description | Data |
|---|---|---|---|---|---|
| Yes | Ramp Run Slope (%) | 4 | No | Flare Slope LT (%) | 12.5 |
| No | Landing Run Slope (%) | 5 | N/A | Flare Traversable RT | N/A |
| No | Landing Cross Slope (%) | 3.6 | Yes | DWS Provided | Yes |
| No | Gutter Run Slope (%) | 12.1 | | Road Cross Slope (%) | N/A |
| No | Gutter Cross Slope (%) | 2.3 | | | |

Remove & Replace Entire Ramp. Remove & Replace Gutter.
