# Access Compliance Report Public Rights-of-Way (Curb Ramps)

| Main Street: N/A | | Cross Street: HARVEST_LN | | Location: | N |
| ADA ID: RPRK210927151632 | Ramp Type: Type 1 - Perpendicular | Initial Pass/Fail: Fail | Overall Compliance: No | Severity Score: | 2 |

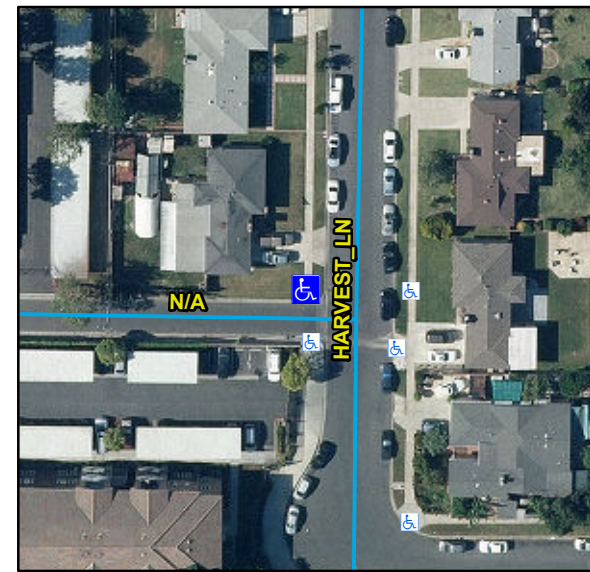
| Compliance | Description | Data | Compliance | Description | Data |
|---|---|---|---|---|---|
| No | Ramp Cross Slope (%) | 2.2 | N/A | Flare Traversable LT | N/A |
| Yes | Overall Surface Condition: <b>Acceptable</b> | | No | Perp Joint Present | No |

**Remove & Replace Entire Ramp.**

**R204.3, R304.5.3, STD 1115**

Total Cost: \$ 3080
