# Access Compliance Report Public Rights-of-Way (Curb Ramps)

| Main Street: HARVEST_LN | | Cross Street: MYSTIC_LN | | Location: | S |
| ADA ID: RPRK210927152035 | Ramp Type: Type 1 - Perpendicular | Initial Pass/Fail: Pass | Overall Compliance: No | Severity Score: | 18 |

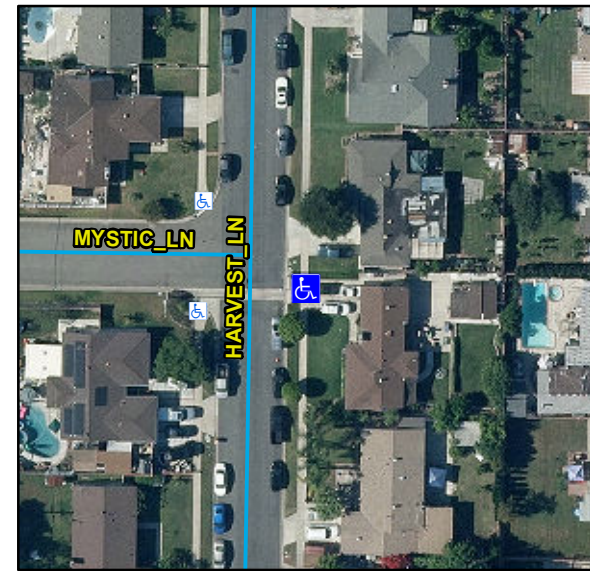
**Residential Driveway**

| Compliance | Description | Data | Compliance | Description | Data |
|---|---|---|---|---|---|
| No | Landing Cross Slope (%) | 2.4 | No | DWS Provided | No |
| No | Gutter Ponding | Yes | Yes | Curb Slope | 1.9 |
| No | Gutter Lip Height (in) | 0.5 | | Road Run Slope (%) | N/A |

**Remove & Replace Entire Ramp. Grind Gutter Lip.**
